PHASE I ENVIRONMENTAL SITE ASSESSMENT

Property Description:
*25 Wheatland Crescent, Provost,
AB Lot 4, Block 46, Plan 802 1020*

Project Number:
110-2032

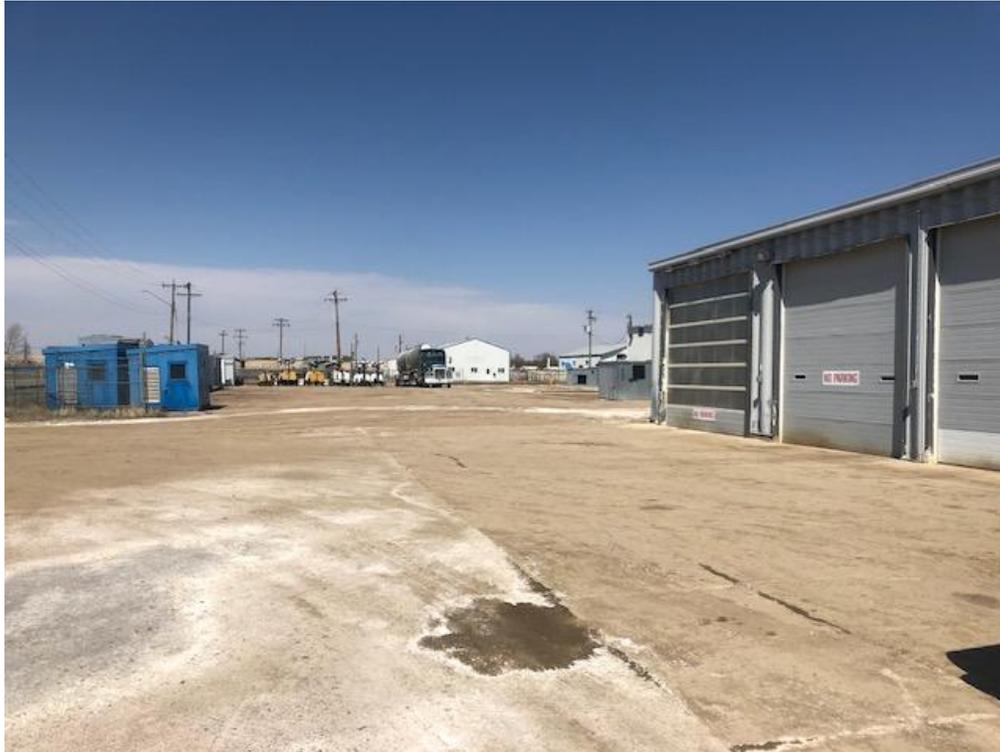
FIGURE 5 – MAIN PARKING AREA

The exterior of the property is graded to drain to the minor storm ditch system and away from the building. Gravel parking is available along the front of the property with access to the site from Wheatland Crescent. There were no signs of stains or distressed vegetation around the property or surrounding areas that would pose an environmental concern at the time of the assessment.

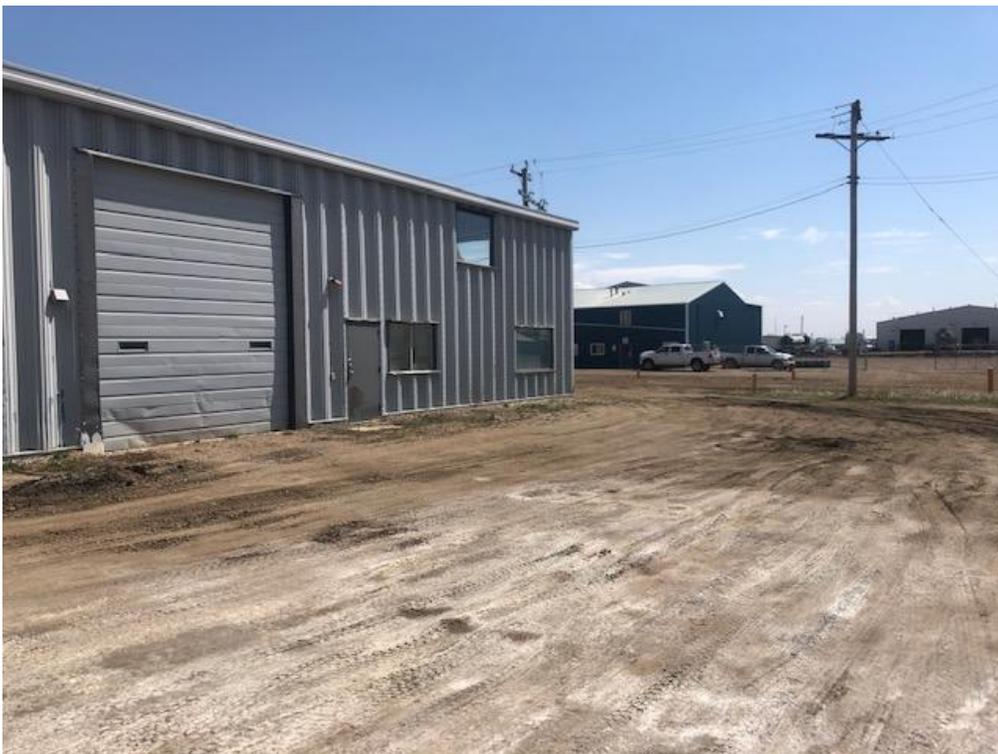
FIGURE 8 – BUILDING EXTERIOR

The existing 12,000 ft² building was constructed in or around 1980. The building is divided into a shop area and front office space with floor drain and sumps and 5 overhead doors. Overall, the building appears to be in excellent shape with no signs of potential environmental contamination.

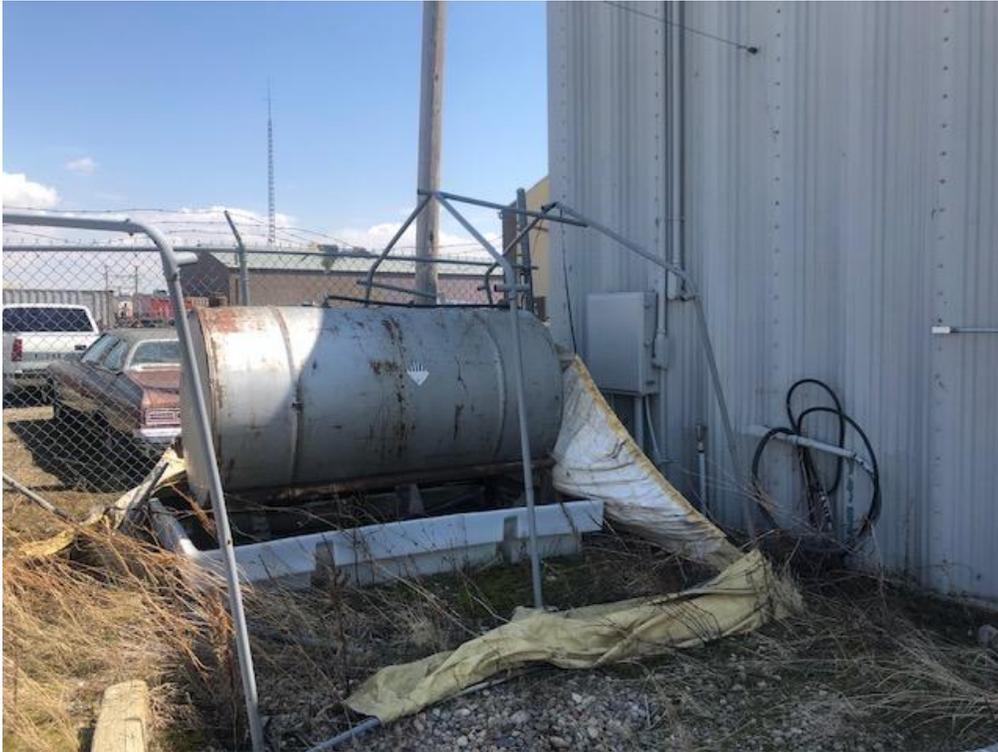
FIGURE 11 – WASTE OIL TANK

- Above Ground Storage Tanks (AST's)
An above ground waste oil tank was observed adjacent to the north end of the building. No evidence of leaks or contamination were noted and there was a secondary spill containment area around the tank.
